Recall Bulletin # 1

Avenger Steering System

Vehicles Affected: All Avenger Models Manufactured in 2004
Prior To Serial Number V22399

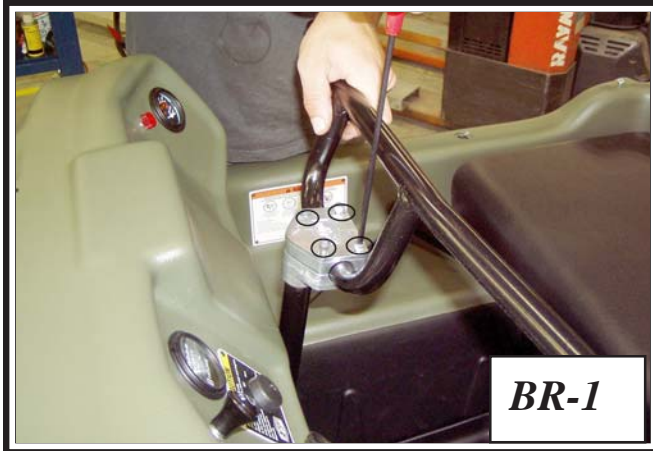
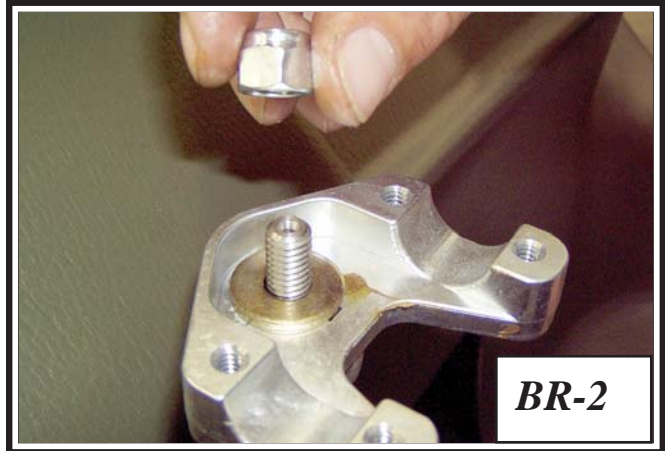
Photo BR-1

1. Perform the servicing procedure, **Removing the Firewall**.
2. Cut the tie wrap securing cables to the steering column.
3. Remove the (4) fasteners securing the steering bar to the steering column assembly.

4. Remove the Nylon Locknut and Flat Washer from the top of the 612-106 Lower Handle Bar Clamp. Discard the nylon locknut. *Photo BR-2*
5. Remove the Lower Handle Bar Clamp from the steering shaft. *Photo BR-3*

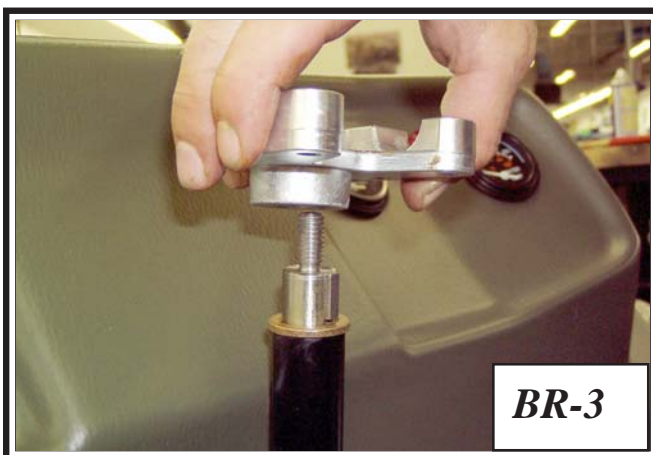
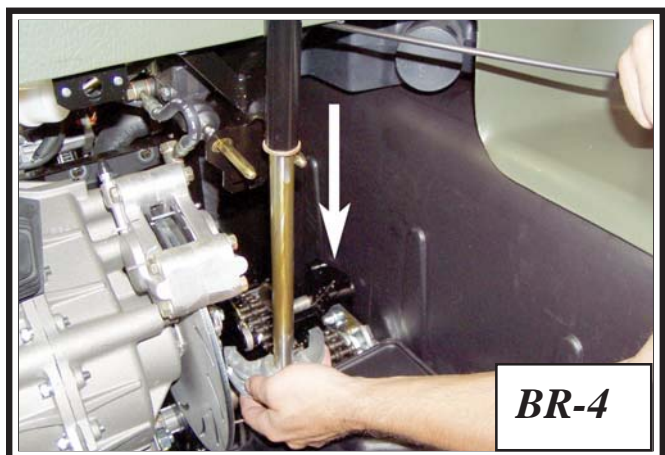
6. Slip the 612-104 Steering Shaft from the Steering Column Assembly. *Photo BR-4*
7. Place the Steering Shaft on a clean work bench and remove the 4 roll pins that come into contact with both centering springs and Steering Arms. *Photo BR-5* Slide each steering arm and centering spring from the shaft. See **NOTE** on following page.

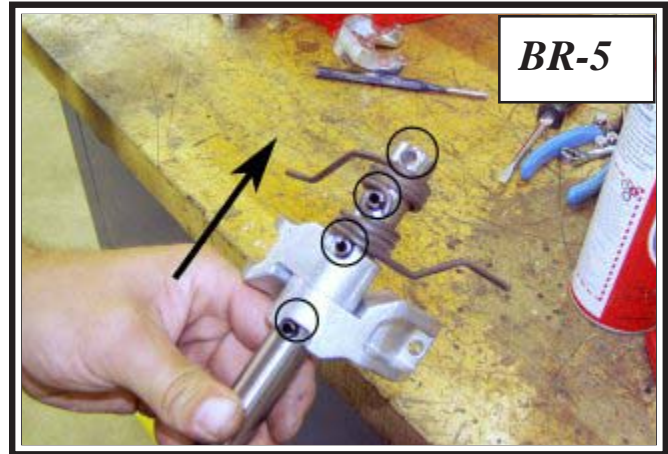
Depending on the serial No. range of your vehicle, the steering shaft may have a retaining ring installed between the 2 steering arms. If this is the case, remove the retaining ring as well. If the steering shaft does not utilize this retaining ring, the steering shaft must be discarded and replaced with the one supplied in the recall parts kit.

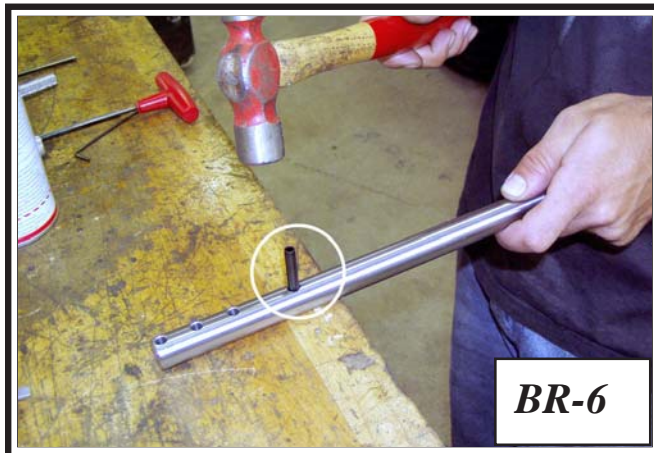
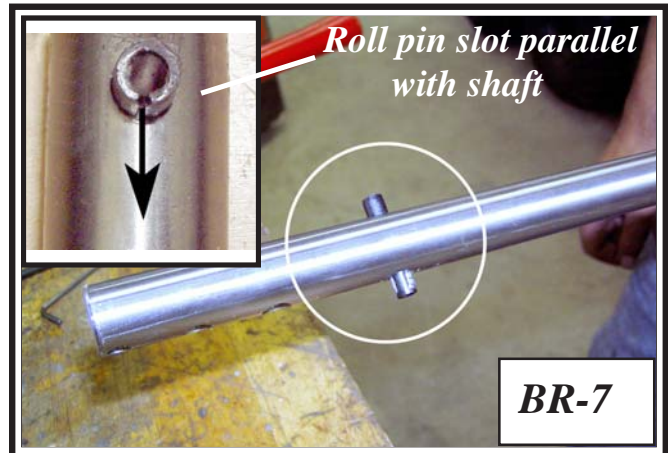
1. Discard the original 612-104 Steering Shaft if it does not have the machined retaining ring groove, and replace it with the one supplied with the recall parts kit. Install one of the new supplied 104-42 Spring Pins into the Steering Shaft at the 4th hole from the end. **Photo BR-6** The roll pin should be installed such that the slot of the pin is parallel to the shaft, and equal amount of pin protrudes on each side of the shaft. **Photo BR-7**

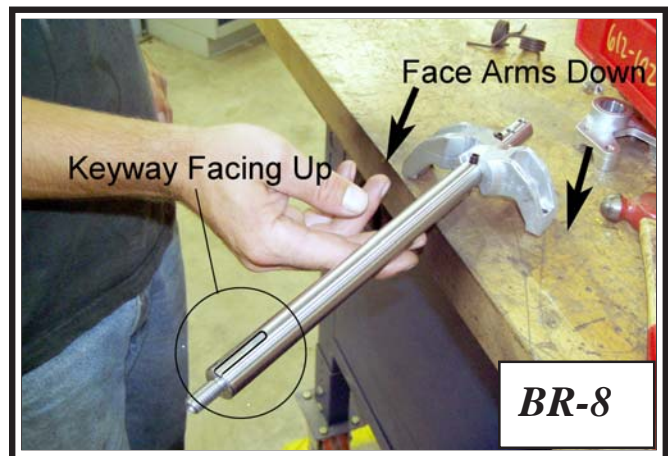
2. Slip the new 612-124 Steering Arm on to the Steering Shaft, followed by the 106-07 retaining ring, seating it to the groove on the shaft. Install the second 612-124 steering arm. Orient them as illustrated in **Photo BR-8**
3. Install the 2nd new supplied 104-42 Spring Pin, followed by a centering spring. Install the 3rd (original) roll pin, followed by a 2nd centering spring and 4th (original) roll pin. **Photo BR-9 & 10**

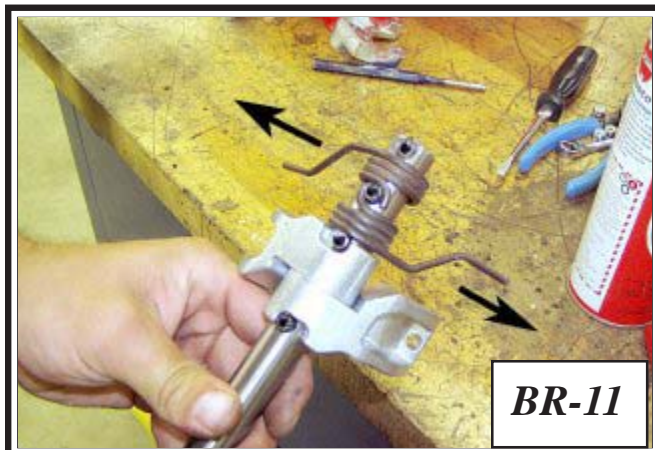
BR-11

NOTE Please observe the orientation of the free end of the springs. Each is pointing in the same direction as the steering arms. **Photo BR-11**

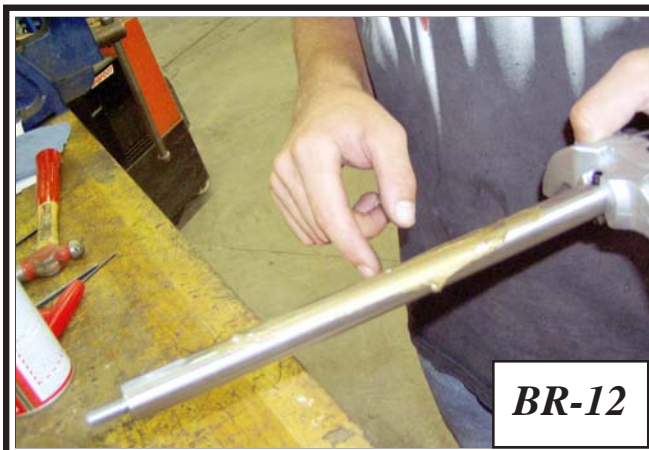
4. Apply some axle grease to the length of the Steering Shaft and insert it from the bottom up into the Steering Column Assembly. **Photo BR-12 & 13**

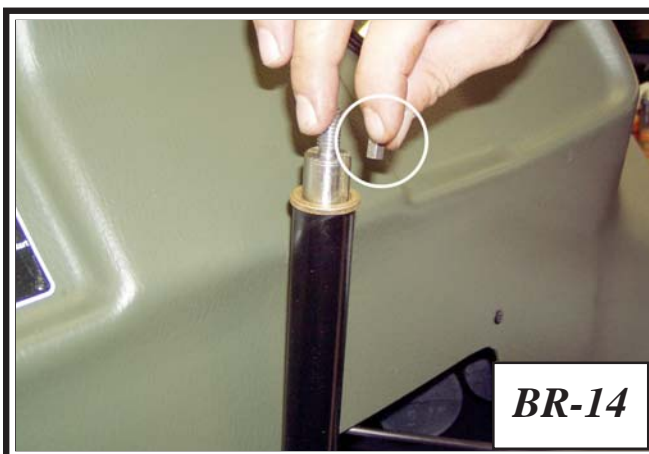
BR-14

5. Place the key to the end of the Steering Shaft. **Photo BR-14**
6. Align the keyway of the Lower Handle Bar Clamp with that of the previously installed key and assemble to the Steering Shaft. **Photo BR-15 & 16**

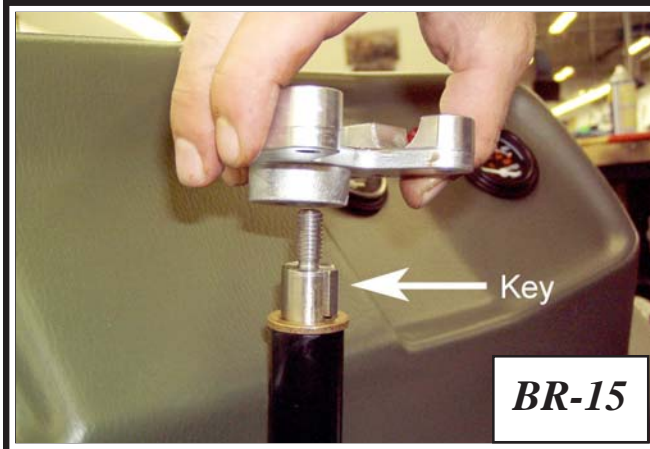
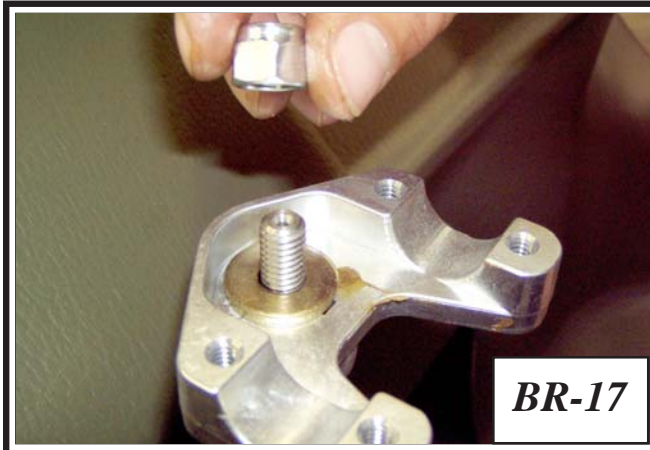
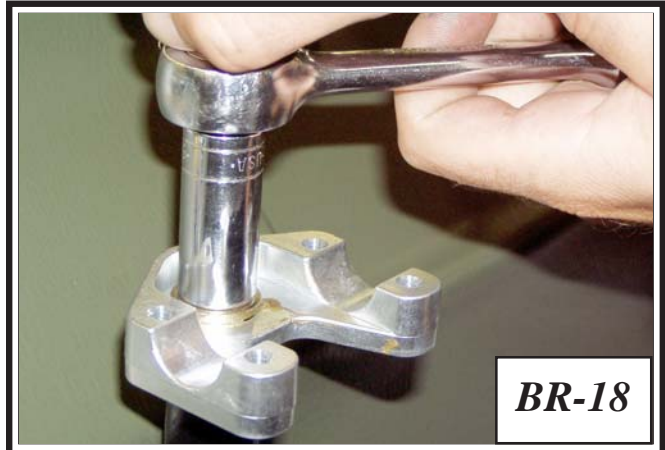
7. Install a Flat Washer and the *new* 117-29 Nylon Locknut supplied to the threaded end of the steering shaft. **Photo BR-17**

8. Tighten down the Nylon Locknut snug. Back off the Locknut just enough to allow the Flat Washer below to be turned by hand. Do not overtighten. Ensure the shaft turns freely with minimal end play. **Photo BR-18**

9. Set the Handle Bar assembly into place and cover with the Upper Handle Bar Clamp. The Handle Bar clamp is secured into place with four fasteners. Tighten down the fasteners in an "X" pattern indifferent to starting location at a torque specification of 10 - 12 Ft. LBS (13.5 - 16N.m) **Photo BR-19**

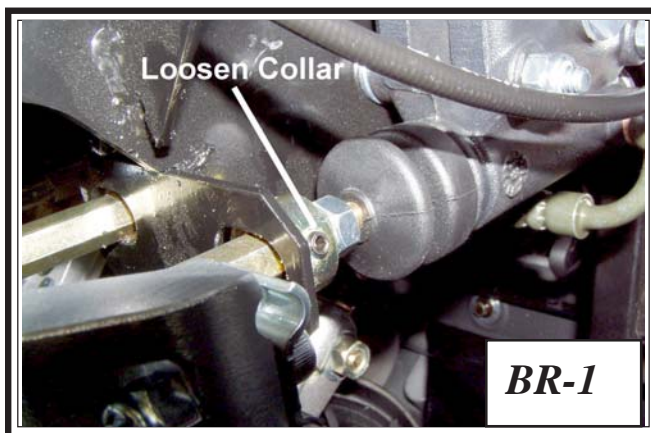
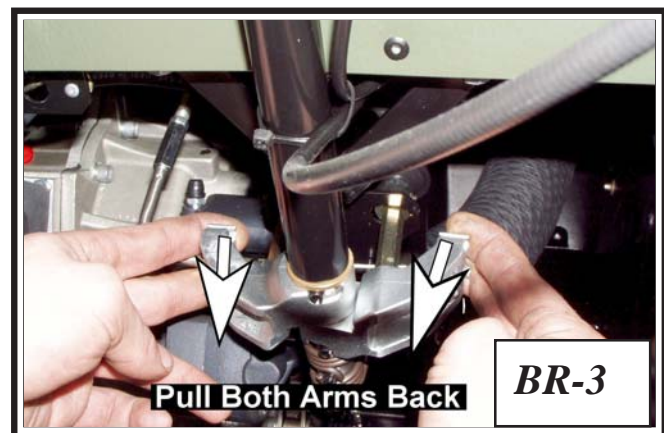
1. Loosen the set screw securing the collar to the plunger pin. *Photo BR-1* This will free the collar to slide along the pin.

Both left and right steering arms should be pulled back to their rear most limit before the plunger pin adjustment is made. Using both hands, pull back on each arm. *Photo BR-3*

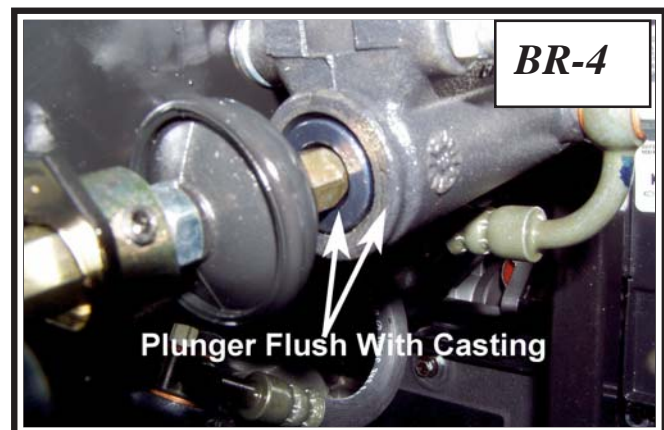
1. Sitting in the vehicle driver's seat, ensure that the steering handle bar is parallel with the dash. Plunger pins should be threaded so they are in contact at the back with the steering arms. Place the collar tightly up against the welded tab stop and secure the set screws with blue LOCTITE.
2. Thread the plunger pins until the master cylinder plunger piston is flush with casting of the master cylinder. *Photo BR-4* Re-tighten all plunger pin jam nuts. Recheck that steering handle bar is still parallel with dash. Repeat procedure if necessary.

Ensure the tab stops that the collars come into contact with are not bent in any way. This will affect how the plunger pin sits when the opposite brake is applied. Any deformity in the tab could cause the plunger pin to become misaligned with it's own steering arm during the application of the opposite brake.
